Manhole Inspection Summary

Manhole # S27G__021MH

Insp Date: **9/4/07 7:59 AM**

Location Address: **918 FAYETTE ST**

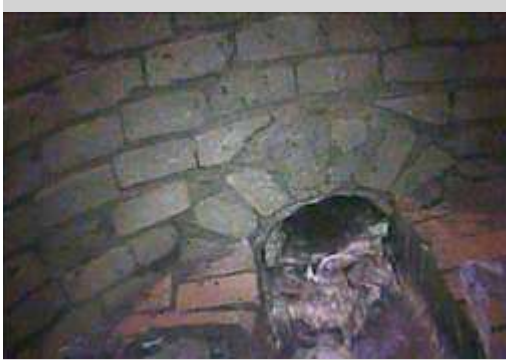
Defect 3

Condition: ☐ Sound ☐ Cracked ☐ Root Intrusion ☐ Deteriorated ☐ Leaks ☒ **Debris**

DEBRIS

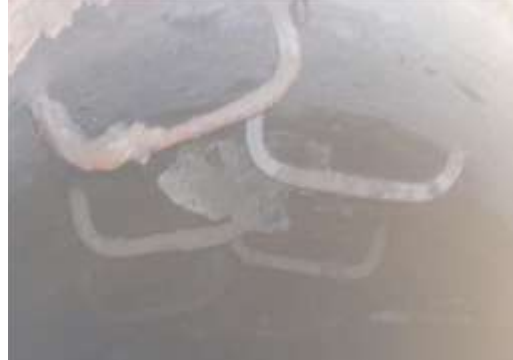
Defect 2

Count: **6** Missing: **0** ☒ **Corroded**

☒ **Evidence Of Surcharge** Depth: **3** (ft.) ☐ Active Surcharge Present

CORRODED STEPS AND SURCHARGE
EVIDENCE

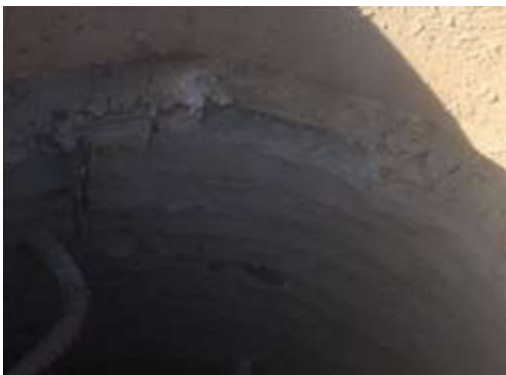
Defect 1

Condition: ☐ Sound ☐ Cracked ☐ Root Intrusion ☐ Loose Brick ☒ **Deteriorated**

DETERIORATED CORBEL

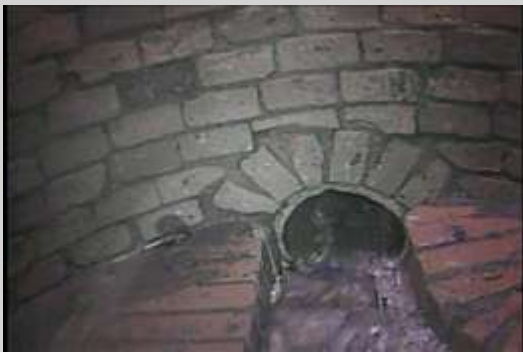
12 O'Clock Outflow

Pipe Height: **7.2** (in.) Rod and Bar (Angled)
Pipe Material: **Clay** ☐ Pipe Lined
Invert Depth: **10.03** (ft.) Flow Characteristics: **Slow**
Deposits: ☐ None ☐ Mud ☐ Sludge ☒ **Debris** ☐ Grease
Silt Depth: **2** (in.) Deposits Extent: **Light**
Infiltration: **None** Pipe Seal Cond: **Sound**

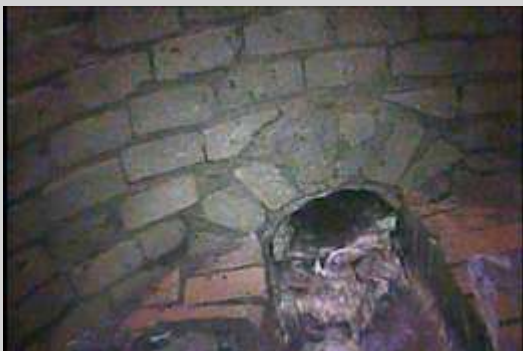
3 O'Clock Inflow

Pipe Height: **8.4** (in.) Rod and Bar (Angled)
Pipe Material: **Clay** ☐ Pipe Lined
Invert Depth: **9.91** (ft.) Flow Characteristics: **Slow**
Deposits: ☐ None ☐ Mud ☐ Sludge ☒ **Debris** ☐ Grease
Silt Depth: **6** (in.) Deposits Extent: **Heavy**
Infiltration: **None** Pipe Seal Cond: **Sound**

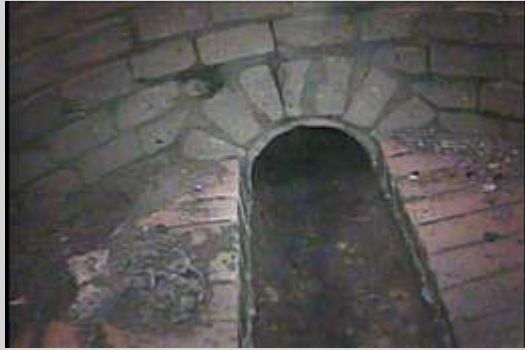
6 O'Clock Inflow

Deposits: ☐ None ☐ Mud ☐ Sludge ☒ **Debris** ☐ Grease

Silt Depth: **1** (in.) Deposits Extent: **Light**
